## BAGGALEY DAM

YOUNGSTOWN BOROUGH MUNICIPAL AUTHORITY

### PHASE I INSPECTION REPORT NATIONAL DAM INSPECTION PROGRAM

MAY 1980

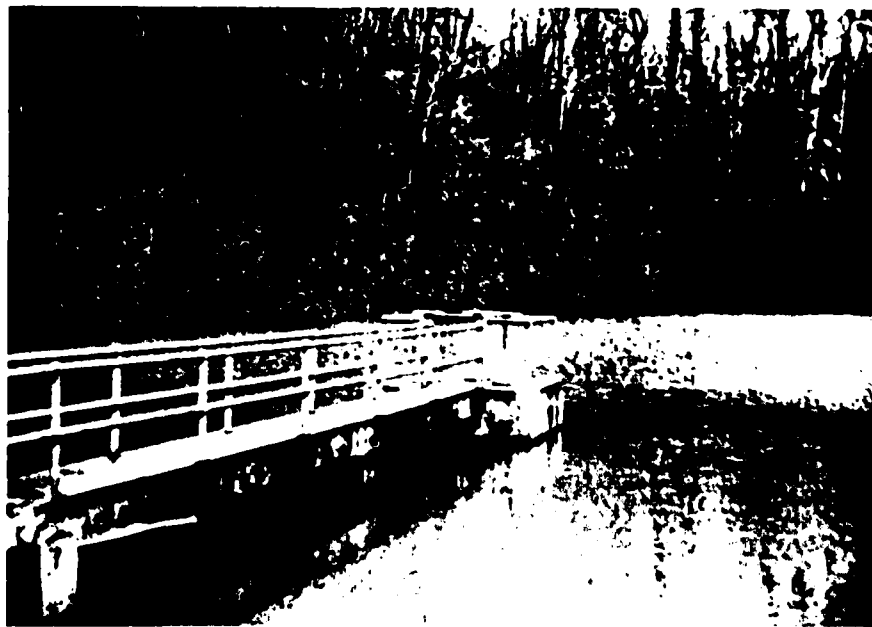
PHOTO 2. WALKWAY AND GATE HOUSE

The condition of the visible portion of the gatehouse was good and the concrete portion of the walkway was fair, with some concrete deterioration. The steel walkway was in good condition as was the pipe handrail.

(1) Intake Structure: The structural condition of the gatehouse and steel walkway appeared to be good. The concrete portion of the walkway was assessed to be in fair condition.

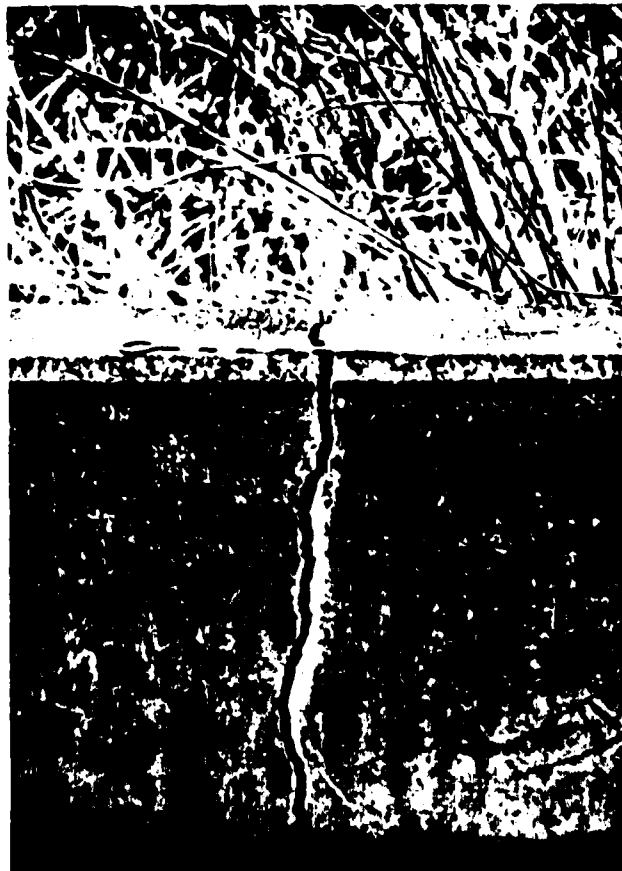
The training walls were both concrete and masonry. On the right side, the concrete walls were in good condition except for a large vertical crack a few feet upstream of the spillway chute. Water was flowing through the crack and disappearing into the rock and gravel foundation materials. A section of masonry training wall on the right side was intact but contained numerous open joints.

Also, the large crack in the right training wall may be an indication of downstream movement of the chute, possibly due to erosion of foundation support once provided by the downstream channel.

PHOTO 8. CRACK IN SPILLWAY TRAINING WALL

(2) Repair cracks and deterioration in the spillway walls and slabs and remove debris from the approach channel.
